Post Incident Summary Report

Incident: Tip Top Bakery Fire
Address: 311 The Horsley Drive, Fairfield
Council: Fairfield City Council

Date of Incident: 2 June 2002

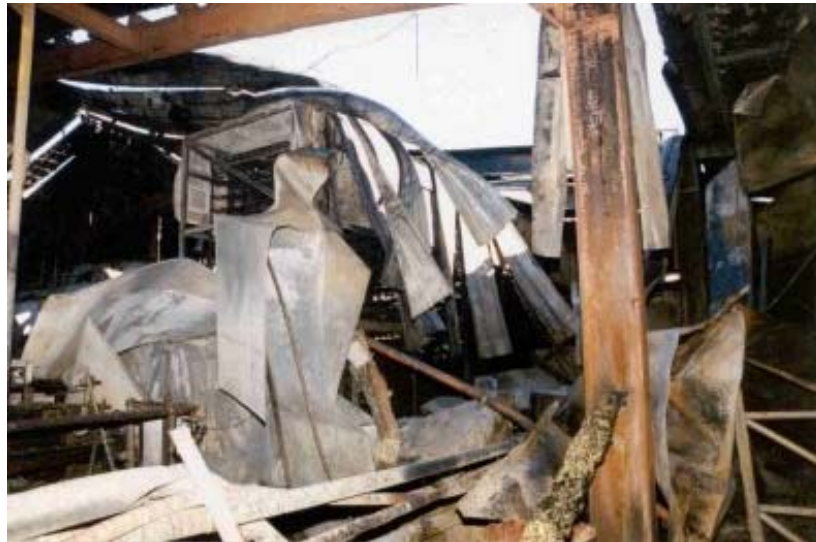
According to Jeffrey Gudman, a private forensic and scientific consultant, investigating the fire on behalf of the insurance company, the cause of the fire was the failure of the three brackets supporting a gas-fired heater that was positioned on top of the muffin-proving oven. The displacement of this heater may have contributed to the ignition of polenta flour dust in the immediate area.

Comment: It has been reported that polenta flour gets trapped in the associated machinery during the muffin production process. It recirculates within the system forming a film of residue on the inside of the machinery and the exhaust ducting leading to the roof area. This would have contributed to the risk, and the subsequent spread, of fire.

The damage caused by the fire in the area of the muffin-proving room.

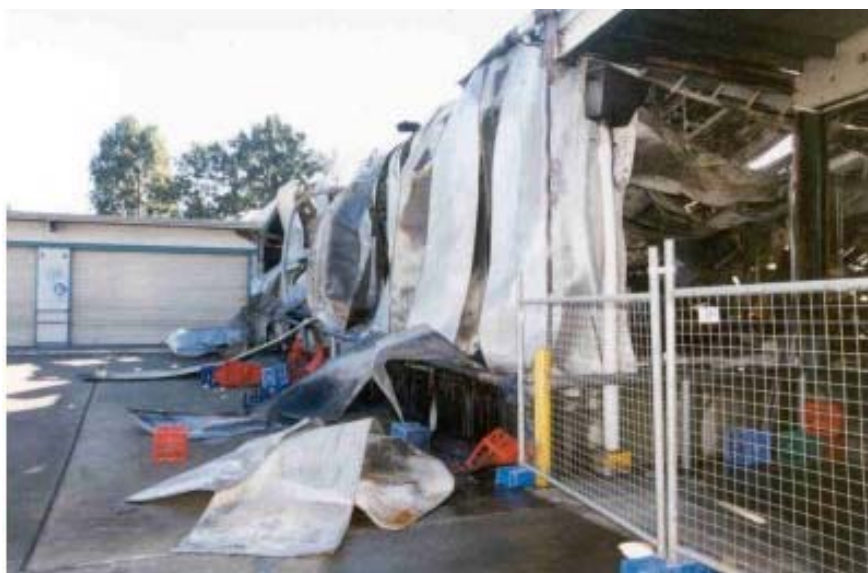
It would appear that the ISPs utilised in the construction of the Tip Top factory were constructed with polystyrene insulation. Construction using **polystyrene** insulated sandwich panels presents several major difficulties for fire fighting:

- The loss of adequate structural integrity and subsequent likelihood of significant building collapse;
- The combustibility of the insulation material adds substantially to the fire load and results in the production of large amounts of heat, smoke and toxic products;
- Fire spread can be hidden within the panels, and
- This fire spread can be rapid, leading to conditions that favour flashover.

These heat affected insulated sandwich panels were located at the front of the factory. Note the absence of the foam cores.

- A copy of this report be sent to the NSWFB Operational Safety Coordinator and the Manager, Training;
- The information on the specific risks associated with buildings using sandwich panel construction be disseminated at the forthcoming Senior Officers' meeting;
- A copy of this report be sent to Standards Australia and they give consideration to the formation of an Australian Standards committee to formulate specific Standards for the use of insulated sandwich panels in construction, including;
 - The provision of fire protection systems such as sprinkler protection, and perhaps plasterboard linings behind the metal skins and joins to prevent flame and heat penetration to the core;
 - The incorporation of pre-finished and sealed areas for penetration of services.

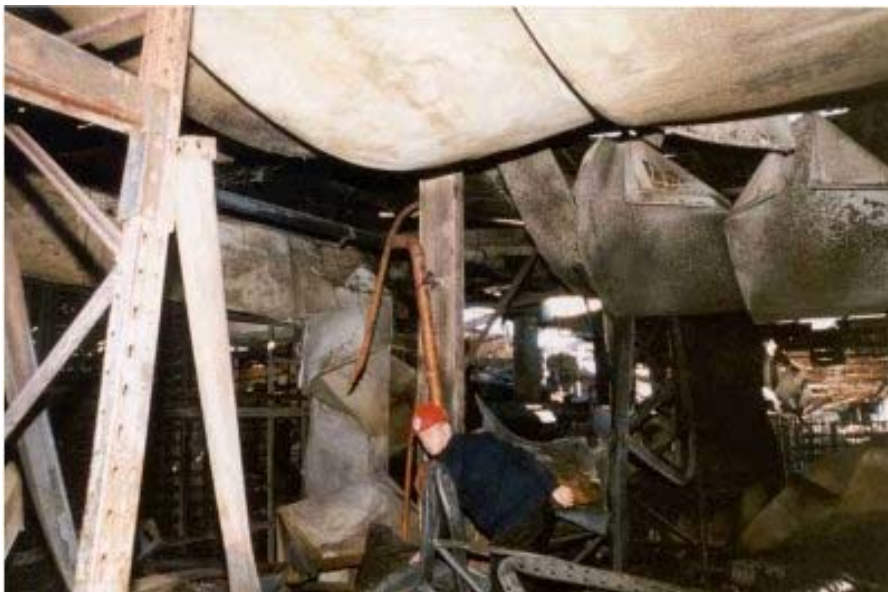
Comment: Water supplies were inadequate during firefighting operations. During the early stages of the fire the internal fire main was rendered inoperable due to fire impingement causing the unprotected pipe to fracture in the north east corner of the building. This resulted in the pillar hydrants on the southern side of the complex being of no use to attending brigades. As part of the fire fighting operations, an appliance gaining water from a feed hydrant in The Horsley Drive was used to boost the fire main, however this water was going to waste at the point of fracture.

An Officer from the NSWFB Fire Safety Division examining the fractured internal fire main at the north east corner of the factory.

- Information is disseminated to Station Commanders regarding the importance of identifying the location of adequate water supplies appropriate to the risk during pre incident planning activities.
